INDOOR AIR QUALITY ASSESSMENT

**Allen Avenue School
290 Allen Avenue
North Attleborough, MA**

Prepared by:
Massachusetts Department of Public Health
Center for Environmental Health
Bureau of Environmental Health Assessment
Emergency Response/Indoor Air Quality Program
March 2005

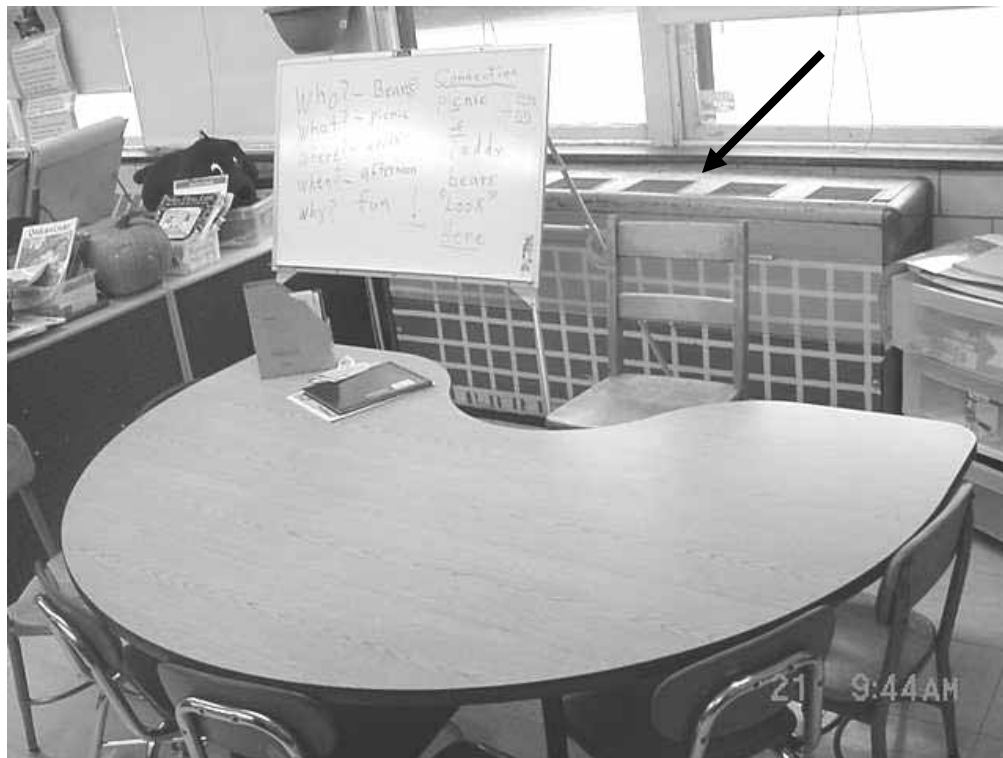
Picture 1

It can be seen from Table 1 that carbon dioxide levels were above 800 parts per million (ppm) parts of air in eighteen of twenty areas surveyed. These results indicate inadequate air exchange in the majority of areas throughout the school on the day of the assessment. Fresh air in classrooms is supplied by unit ventilator (univent) systems (Picture 1). A univent is designed to draw air from outdoors through a fresh air intake located on the exterior wall of the building (Picture 2) and returns air through an air intake located at the base or side of the unit ([Figure 1](#)). Fresh and return air are mixed and filtered, then heated and provided to classrooms through an air diffuser located in the top of the unit. Univents are equipped with fan control settings of low, medium or high (Picture 3). Univents are reportedly original equipment, approximately 50-55 years old. Univents of this age can be difficult to maintain because replacement parts are often unavailable. Several univents were found deactivated during the assessment. Obstructions to airflow, such as papers and books stored on univents and bookcases, carts and desks near univent returns, were also seen in several classrooms. In order for univents to provide fresh air as designed, they must remain activated and allowed to operate while rooms are occupied. Intakes and air diffusers must also remain free of obstructions.

Classroom Univent

1. Examine each univent for function. Survey classrooms for univent function to ascertain if an adequate air supply exists for each room. Consider consulting a heating, ventilation and air conditioning (HVAC) engineer concerning the calibration of univent fresh air control dampers throughout the AAS.

2. Operate all ventilation systems that are operable throughout the building (e.g., gym, auditorium, classrooms) continuously during periods of school occupancy and independent of thermostat control. To increase airflow in classrooms, set univent controls to “high”.

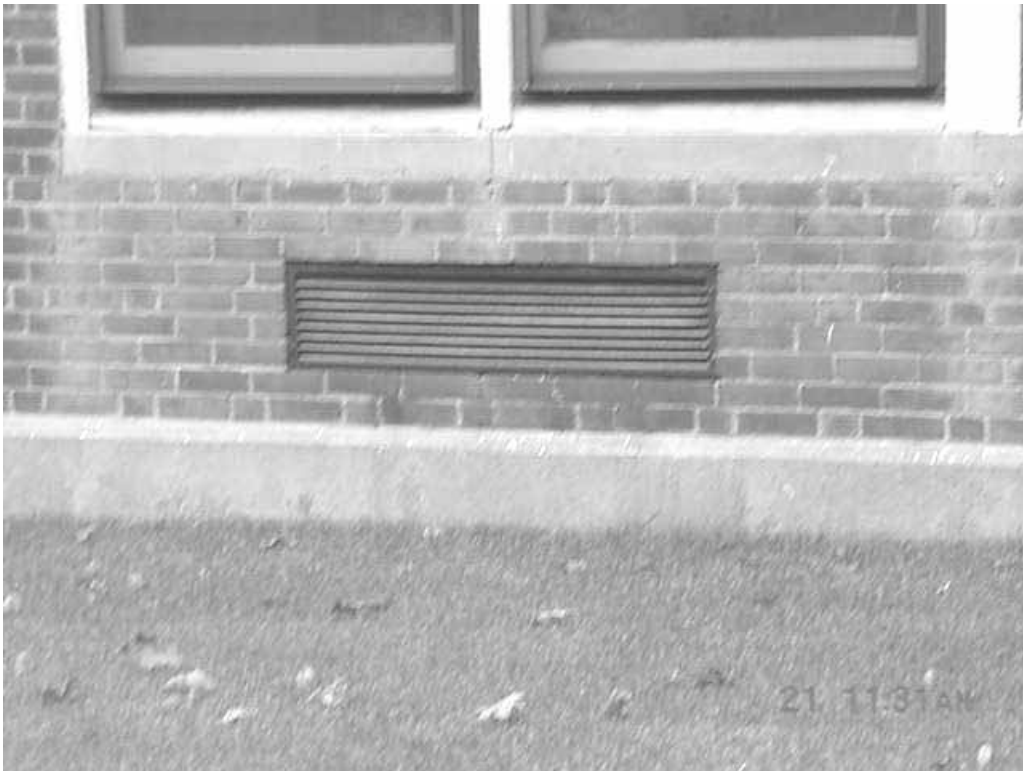
Picture 2

Univent Fresh Air Intake

3. Set the thermostats for modular classrooms to the fan “on” position to operate the ventilation system continuously during the school day.
4. Remove all blockages from univents and exhaust vents to ensure adequate airflow.

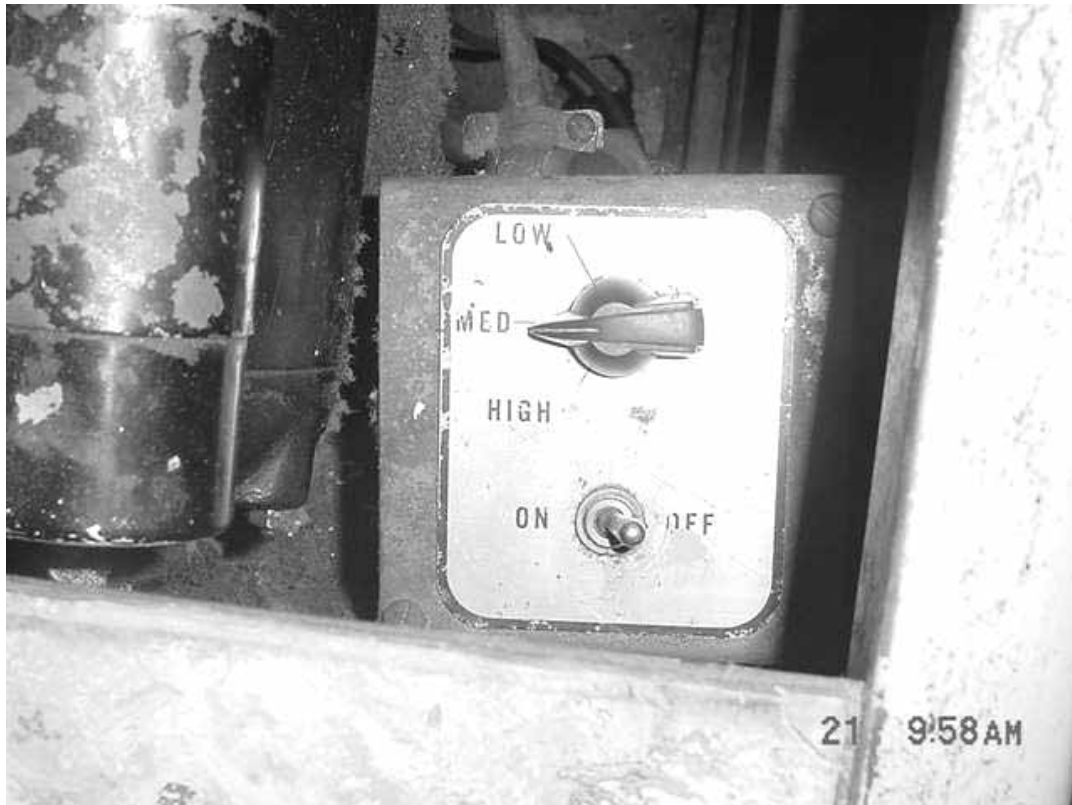
Picture 3

Univent Fan Speed Control, Note That This Unit was Deactivated

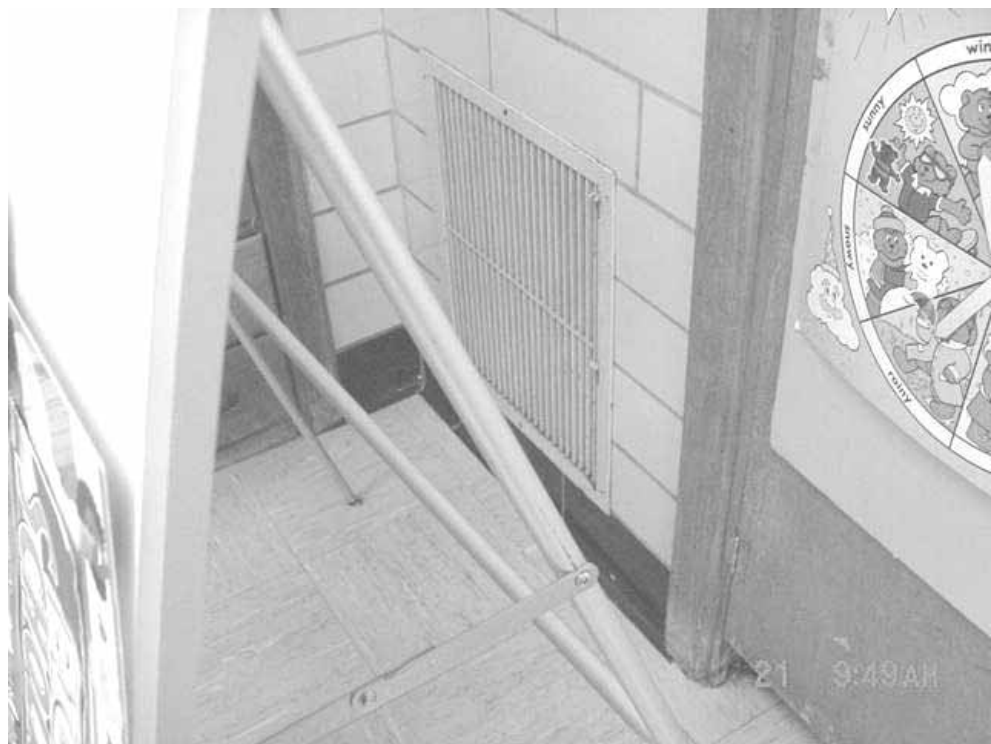
Picture 4

Exhaust ventilation in classrooms was originally provided by ducted, grated wall vents powered by rooftop wind turbines (Pictures 4 and 5). Many of these wall vents were obstructed at the time of the assessment (Picture 6). The turbine-driven wall exhausts are supplemented by vents located in the ceilings of coat closets (Picture 7), which are also powered by non-mechanical rooftop wind-driven turbines. Air is drawn into the coat closet from the classroom via undercut closet doors and removed from the building (Picture 8). Neither the wall nor closet vents were drawing air during the assessment. In addition, the location of the vents in the closet allows them to be easily blocked by stored materials (Picture 7). As with the univents, in order to function properly, exhaust vents must be free of obstructions.

Wall-Mounted Exhaust Vent

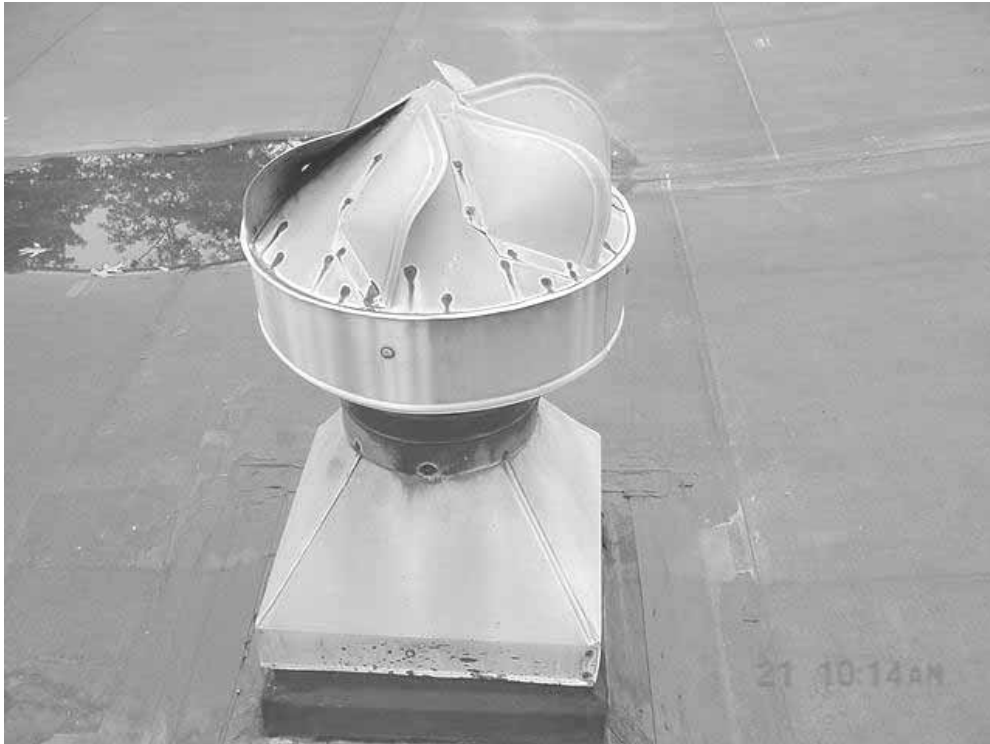
Picture 5

Wind-Driven Turbine Exhaust System, Note Fan Blades on Top of Unit

1. Continue with plans to replace/repair window systems throughout the building to prevent water penetration and drafts through window frames.
2. Contact an HVAC engineering firm to determine if wind-driven turbines on the roof can be retrofitted with modern mechanical exhaust motors.

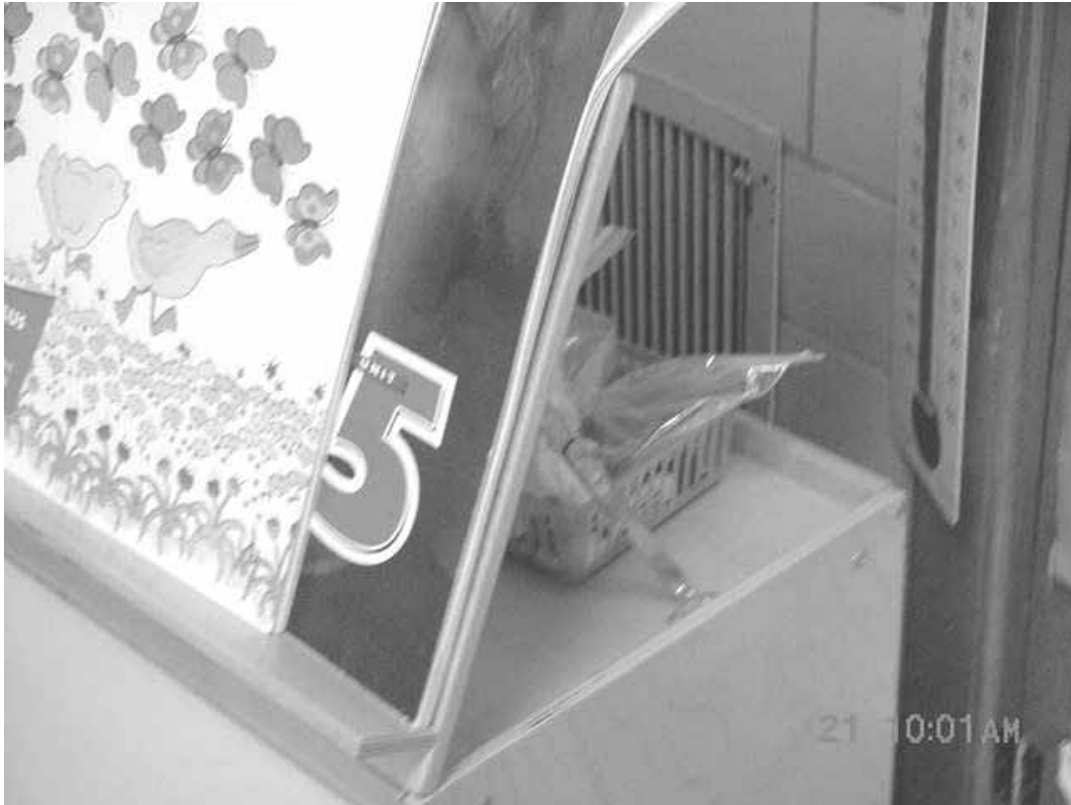
Picture 6

Obstructed Wall-Mounted Exhaust Vent

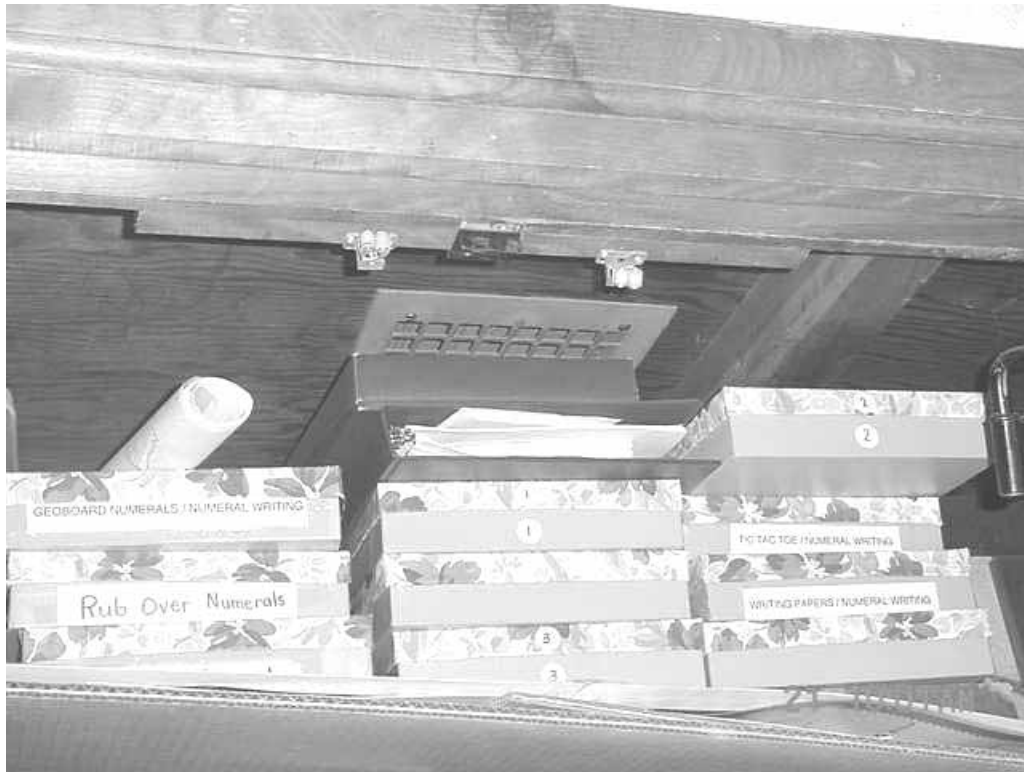
Picture 7

Coat Closet Exhaust Vent, Note Storage of Materials

11. Relocate or consider reducing the amount of materials stored in classrooms to allow for more thorough cleaning. Clean items regularly with a wet cloth or sponge to prevent excessive dust build-up.

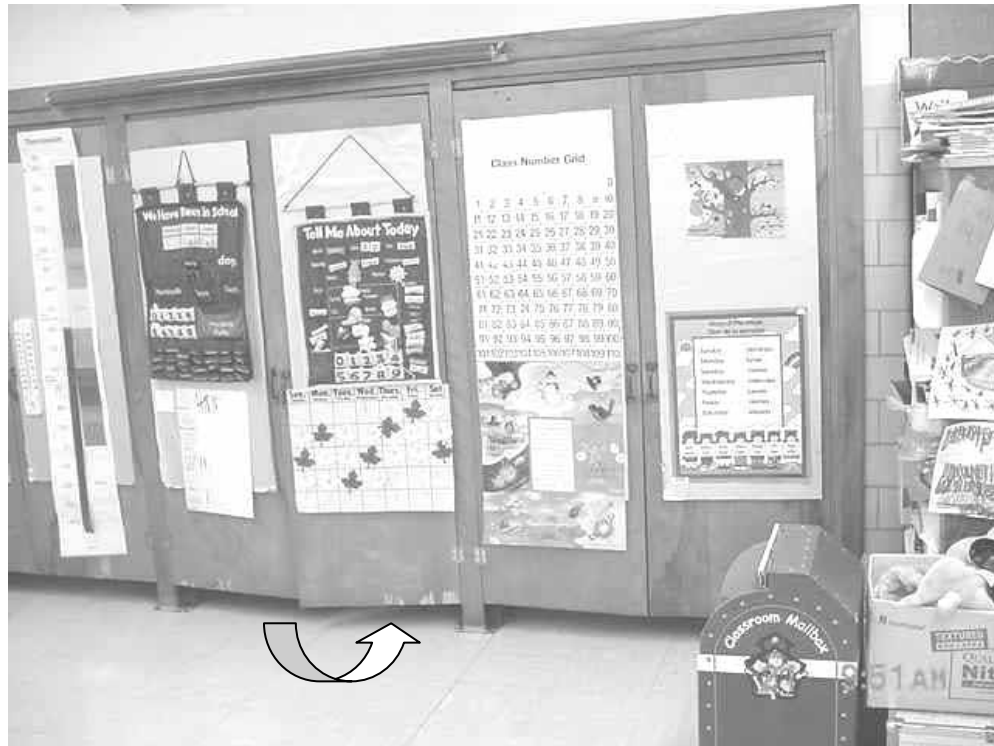
Picture 8

Undercut Coat Closet Doors

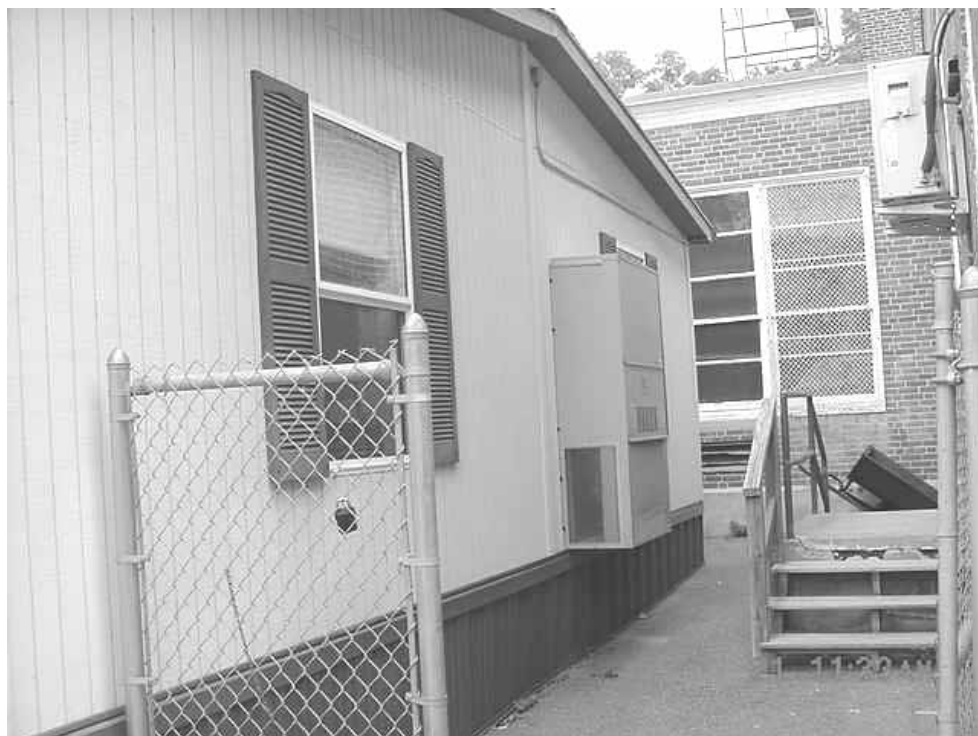
Picture 9

Mechanical ventilation for modular classrooms is provided by AHUs mounted on the exterior of each classroom (Picture 9). Fresh air is distributed to classrooms via a wall-mounted air diffuser and drawn back to the AHUs through a wall-mounted return vent (Picture 10). Thermostats control each heating, ventilating and air conditioning (HVAC) system and have fan settings of “on” and “automatic”. Thermostats were set to the “automatic” setting (Picture 11) in both of the modular rooms surveyed during the assessment. The automatic setting on the thermostat activates the HVAC system at a preset temperature. Once the preset temperature is reached, the HVAC system is deactivated. Therefore, no mechanical ventilation is provided until the thermostat re-activates the system.

Air Handling Unit Mounted on the Exterior of Modular Classroom

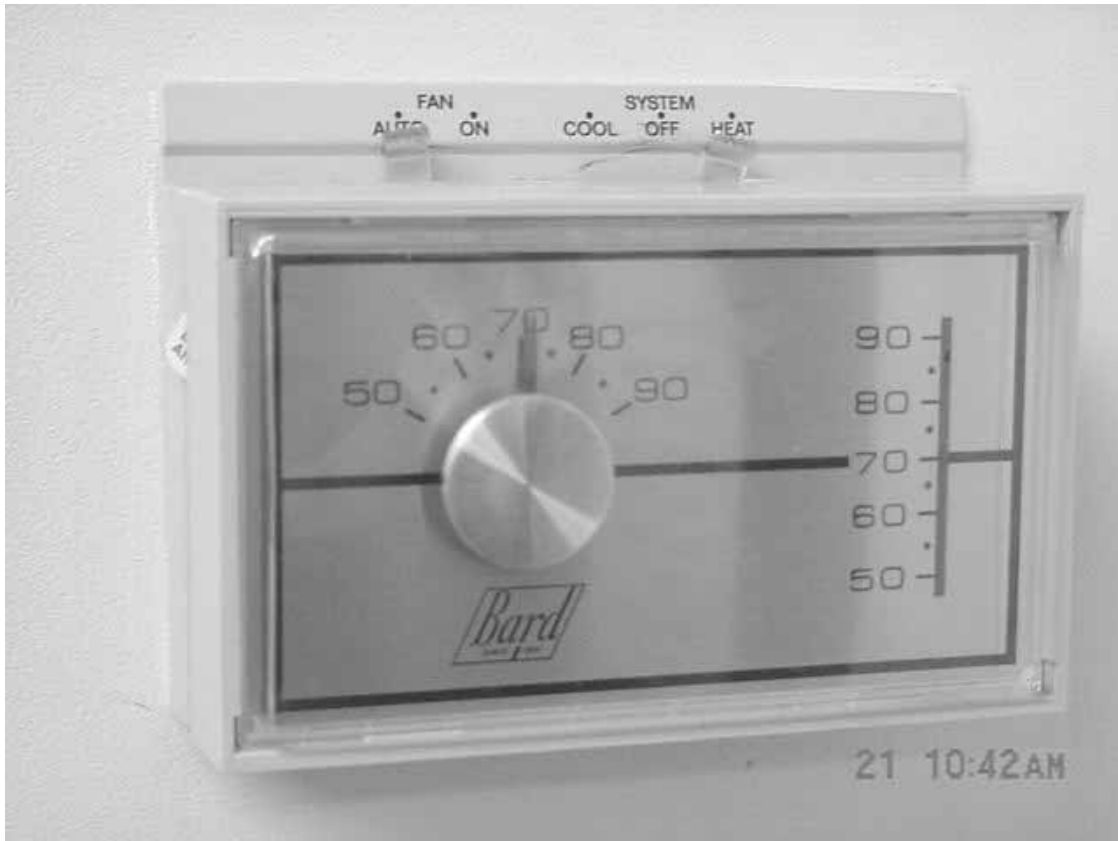
Picture 11

Modular Classroom Thermostat, Note Fan Setting on “Auto”

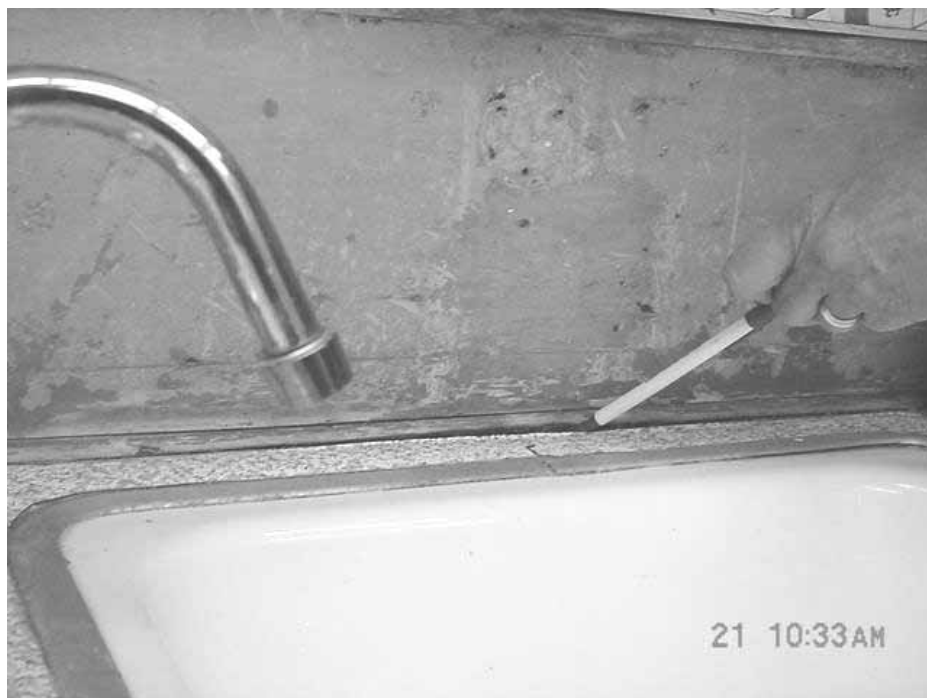
Picture 12

Spaces between the sink countertop and backsplash were noted in several classrooms. Improper drainage or sink overflow can lead to water penetration moistening countertop wood, the cabinet interior and behind the cabinets. Like other porous materials, if these materials become wet repeatedly they can provide a medium for mold growth. Mold growth was observed and musty odors were detected in classroom 1. These odors appeared to be produced by the backsplash, which had become water damaged from repeated exposure to moisture (Picture 12).

Water-Damaged Wooden Backsplash in Classroom 1

7. Replace water damaged wooden splashboard in classroom 1. Examine behind and around this areas for microbial growth. Disinfect areas of water leaks with an appropriate antimicrobial.

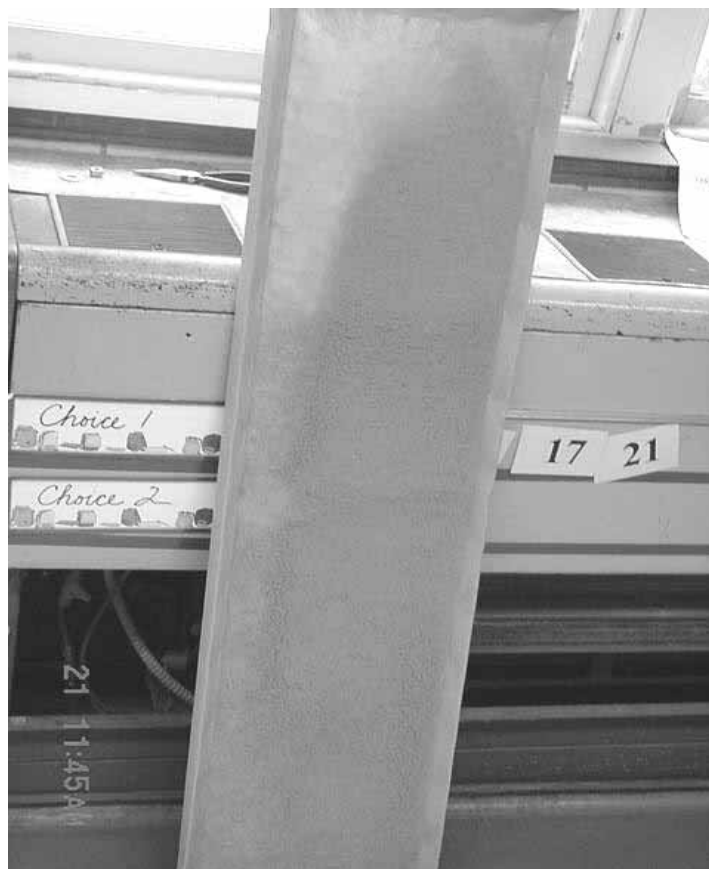
Picture 13

Several other conditions that can affect indoor air quality were noted during the assessment. Univents in the original building had accumulated dust, cobwebs and debris within the air handling chambers and on filters (Picture 13). Also of note was the amount of materials stored inside classrooms. In classrooms throughout the school, items were observed on windowsills, tabletops, counters, bookcases and desks. The large number of items stored in classrooms provides a source for dusts to accumulate. These items (e.g., papers, folders, boxes) make it difficult for custodial staff to clean. Items should be relocated and/or be cleaned periodically to prevent excessive dust build up. Dust can be irritating to eyes, nose and respiratory tract.

Dusty Filter in Univent

10. Change filters for univents and window-mounted air conditioners as per the manufacturer's instructions or more frequently if needed. Vacuum interior of units prior to activation to prevent the aerosolization of dirt, dust and particulates.

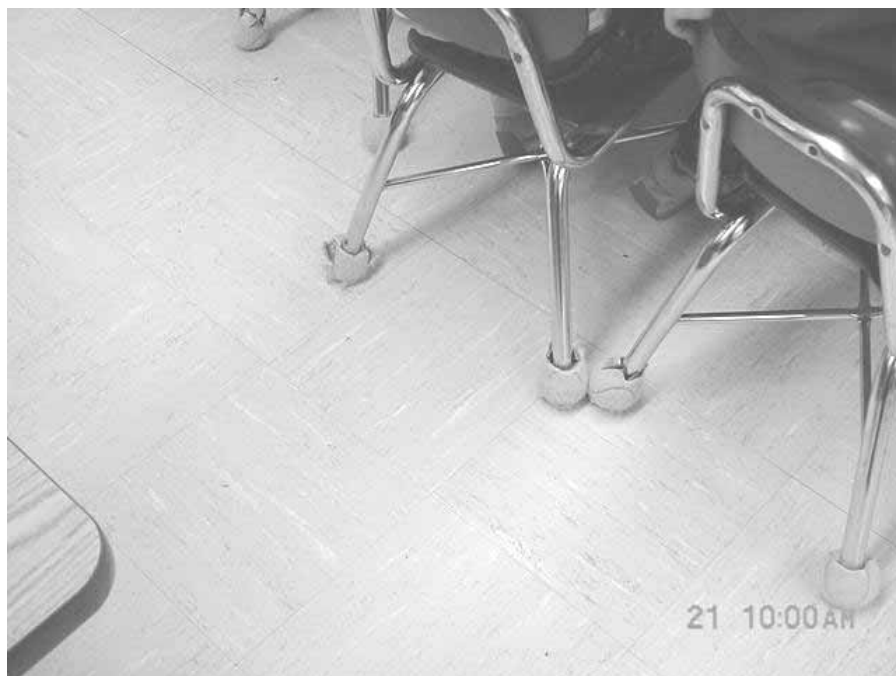
Picture 14

In an effort to reduce noise from sliding chairs, tennis balls had been sliced open and placed on chair legs (Picture 14). Tennis balls are made of a number of materials that are a source of respiratory irritants. Constant wearing of tennis balls can produce fibers and cause TVOCs to off-gas. Tennis balls are made with a natural rubber latex bladder, which becomes abraded when used as a chair leg pad. Use of tennis balls in this manner may introduce latex dust into the school environment. Some individuals are highly allergic to latex (e.g., spina bifida patients) (SBAA, 2001). It is recommended that the use of materials containing latex be limited

Tennis Balls on Chair Legs

12. Consider discontinuing the use of tennis balls on chairs to prevent latex dust generation. Continue with plans to purchase "glides".
13. Consider adopting the US EPA (2000b) document, "Tools for Schools", to maintain a good indoor air quality environment on the building. This document can be downloaded from the Internet at: <http://www.epa.gov/iaq/schools/index.html>.

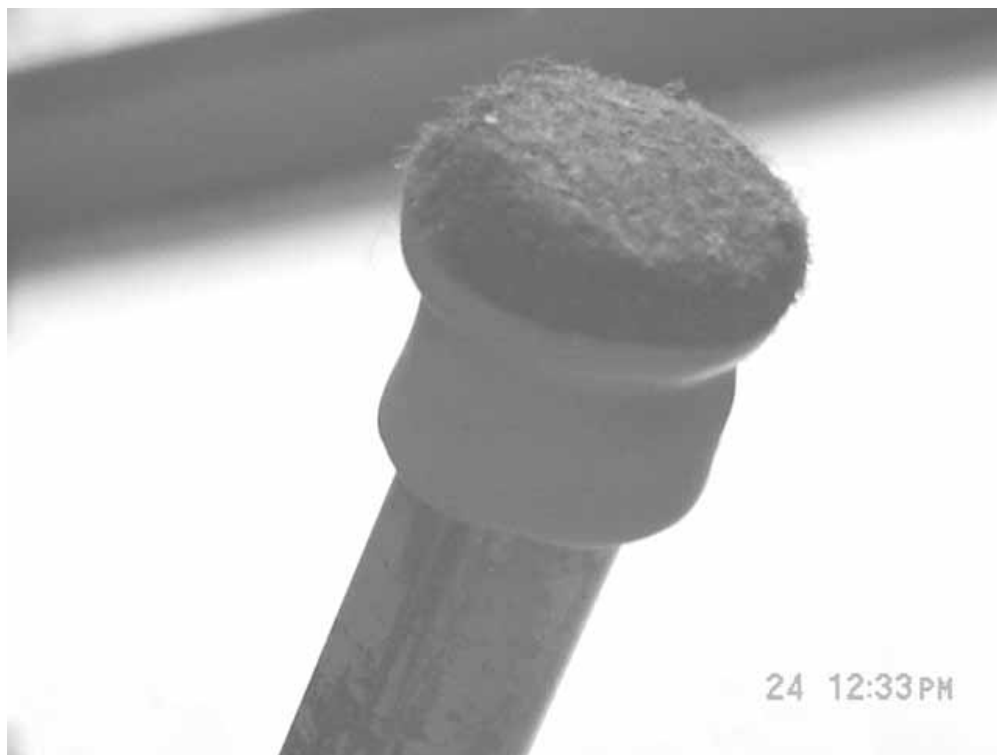
Picture 15

in buildings to reduce the likelihood of symptoms in sensitive individuals (NIOSH, 1997). A question and answer sheet concerning latex allergy is attached as [Appendix B](#) (NIOSH, 1998). In many areas, alternative “glides” are used on chair legs (Picture 15). School officials reportedly ordered more glides to replace tennis balls.

“Glides” for Chair Legs that can be used as an Alternative to Tennis Balls
